Manhole Inspection Summary

Manhole # S25GG1036MH

Insp Date: **1/19/07 8:59 AM**

Location Address: **1200 40TH ST**

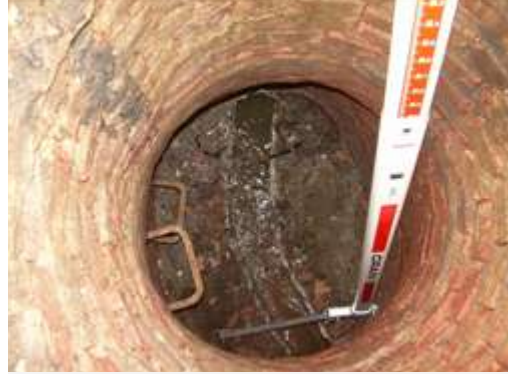
Top View

Corroded steps. Evidence of surcharge - Bench debris.

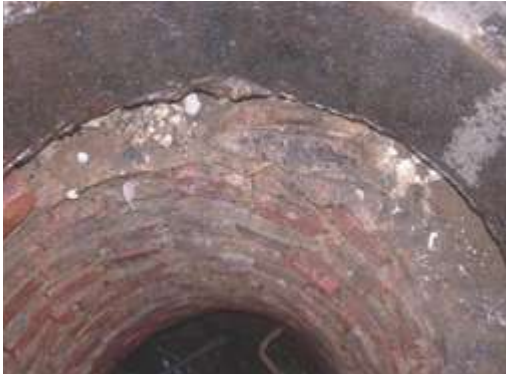
Defect

Frame Offset: **2** (in.) Condition: ☐ Sound ☐ Cracked ☒ **Leaks**

Chimney / Frame Adjustment ☒ Exists Material: **Brick** ☐ Parged Height: **24** (in.)
Condition: ☐ Sound ☐ Cracked ☐ Root Intrusion ☒ **Loose Brick** ☒ **Deteriorated**
Infiltration: ☐ None ☒ **Joint** ☐ Cracks ☒ **Mortar** ☐ Roots ☒ **Wall**

Corbel Material: **Brick** ☐ Parged Type: **Concentric/Eccentric**
Condition: ☐ Sound ☐ Cracked ☐ Root Intrusion ☒ **Loose Brick** ☒ **Deteriorated**
Infiltration: ☐ None ☐ Joint ☐ Cracks ☒ **Mortar** ☐ Roots ☐ Wall

Frame leaks. Frame offset. Adjustment and Corbel deterioration, loose brick and infiltration.

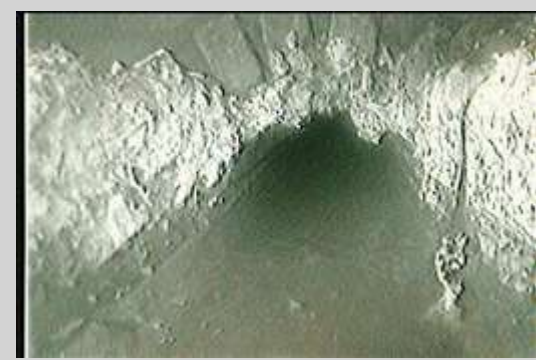
Pipe Out @ 12 O'Clock

Deposits: ☐ None ☐ Mud ☐ Sludge ☐ Debris ☒ **Grease**

Silt Depth: **0** (in.) Deposits Extent: **Medium**

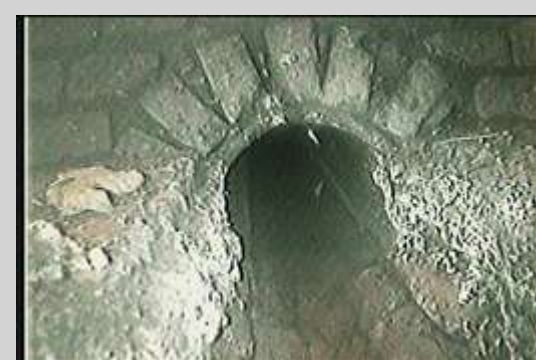
Pipe In @ 5 O'Clock

Deposits: ☐ None ☐ Mud ☐ Sludge ☐ Debris ☒ **Grease**

Silt Depth: **0** (in.) Deposits Extent: **Light**
